**CONFIDENTIAL
COPY NO.:****Report No.: FMCE/3100015707(22-23)/SS/548(22-23)****Date:27.02.2023****TEST REPORT OF
IMPACT TEST ON MACHINE GUARDS**

Sr. No.	Description	Details
01	Title	Machine Guards (Weld Mesh Panels)
02	Type	SWIZA MACHINE GUARD 40 X 60 SERIES
03	Size	2050mm x 1000 mm along with post 2200 mm

- 4.0 OBJECTIVE** :
- 4.1 To conduct the impact test on SWIZA MACHINE GUARD 40 X 60 SERIES panel as per customers guidelines and with reference to standard ISO 14120.

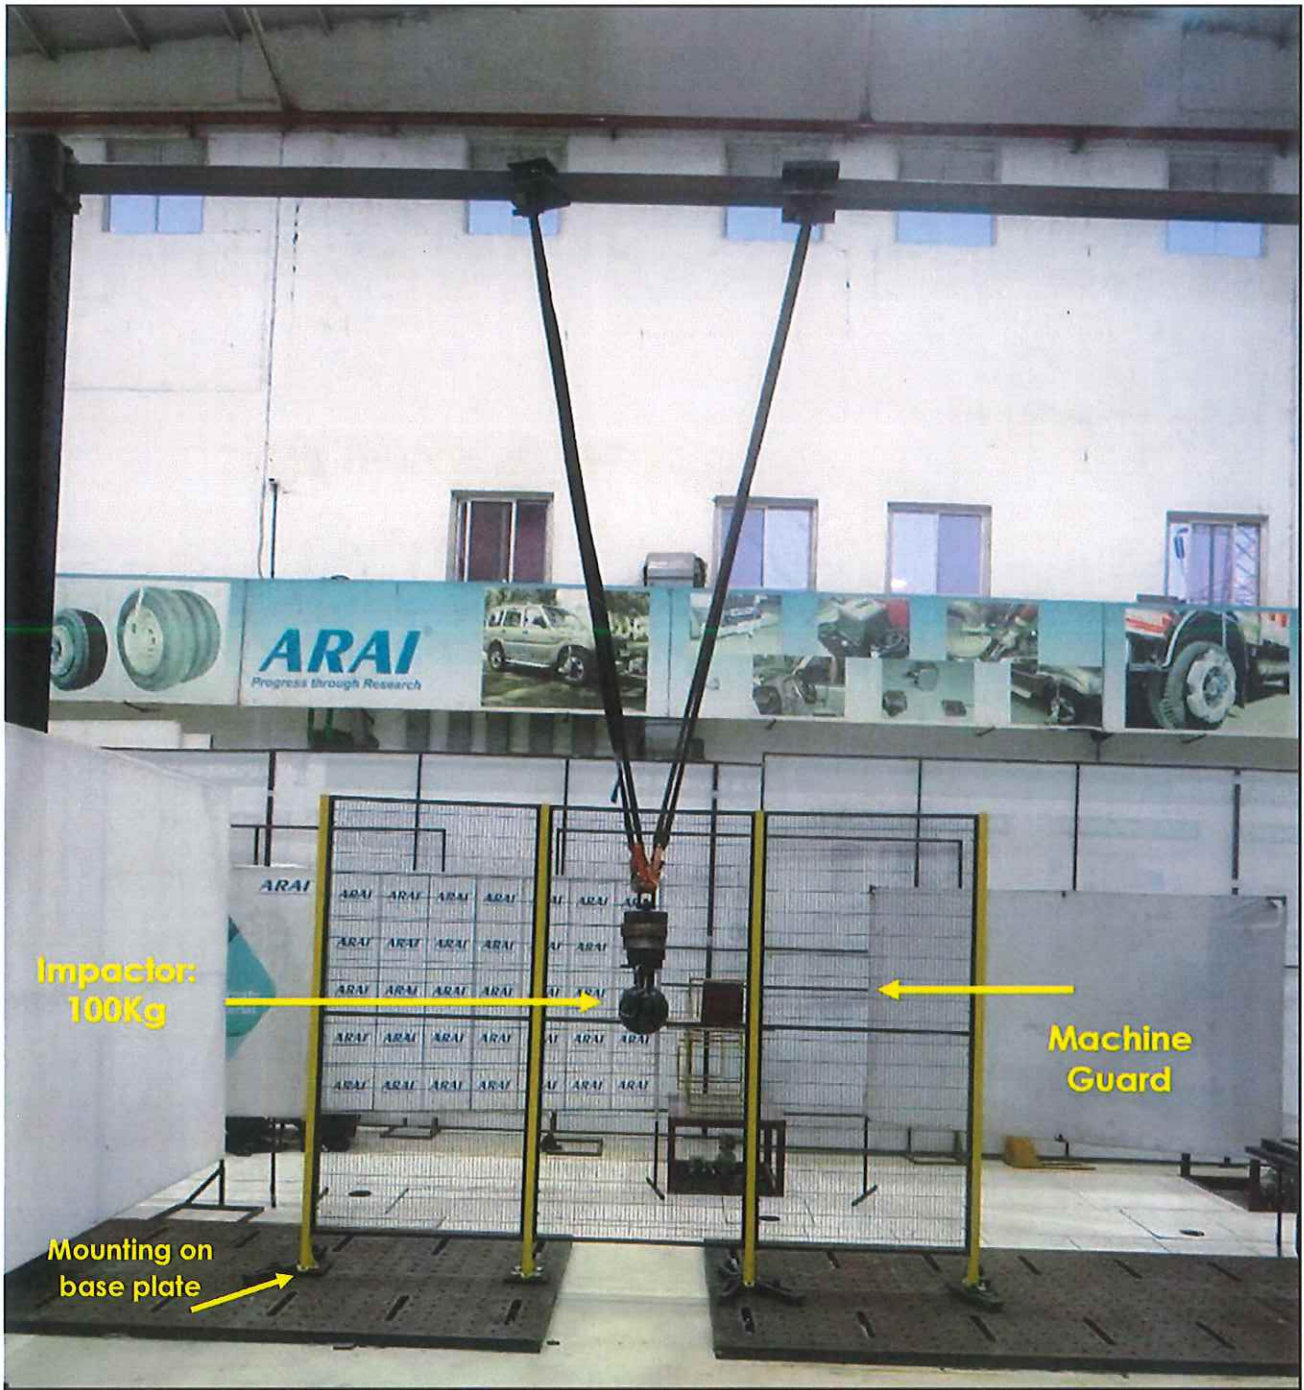
Figure 01 : Test Setup

- 7.2 Assembly of Machine guards were fixed rigidly on base plate. Pendulum of 100 kg was fixed at height of 1631 mm from initial position of pendulum, so as to achieve impact energy of 1600 J (by using $E = m.g.h$ formula). Refer Annexure-I, Figure 01.

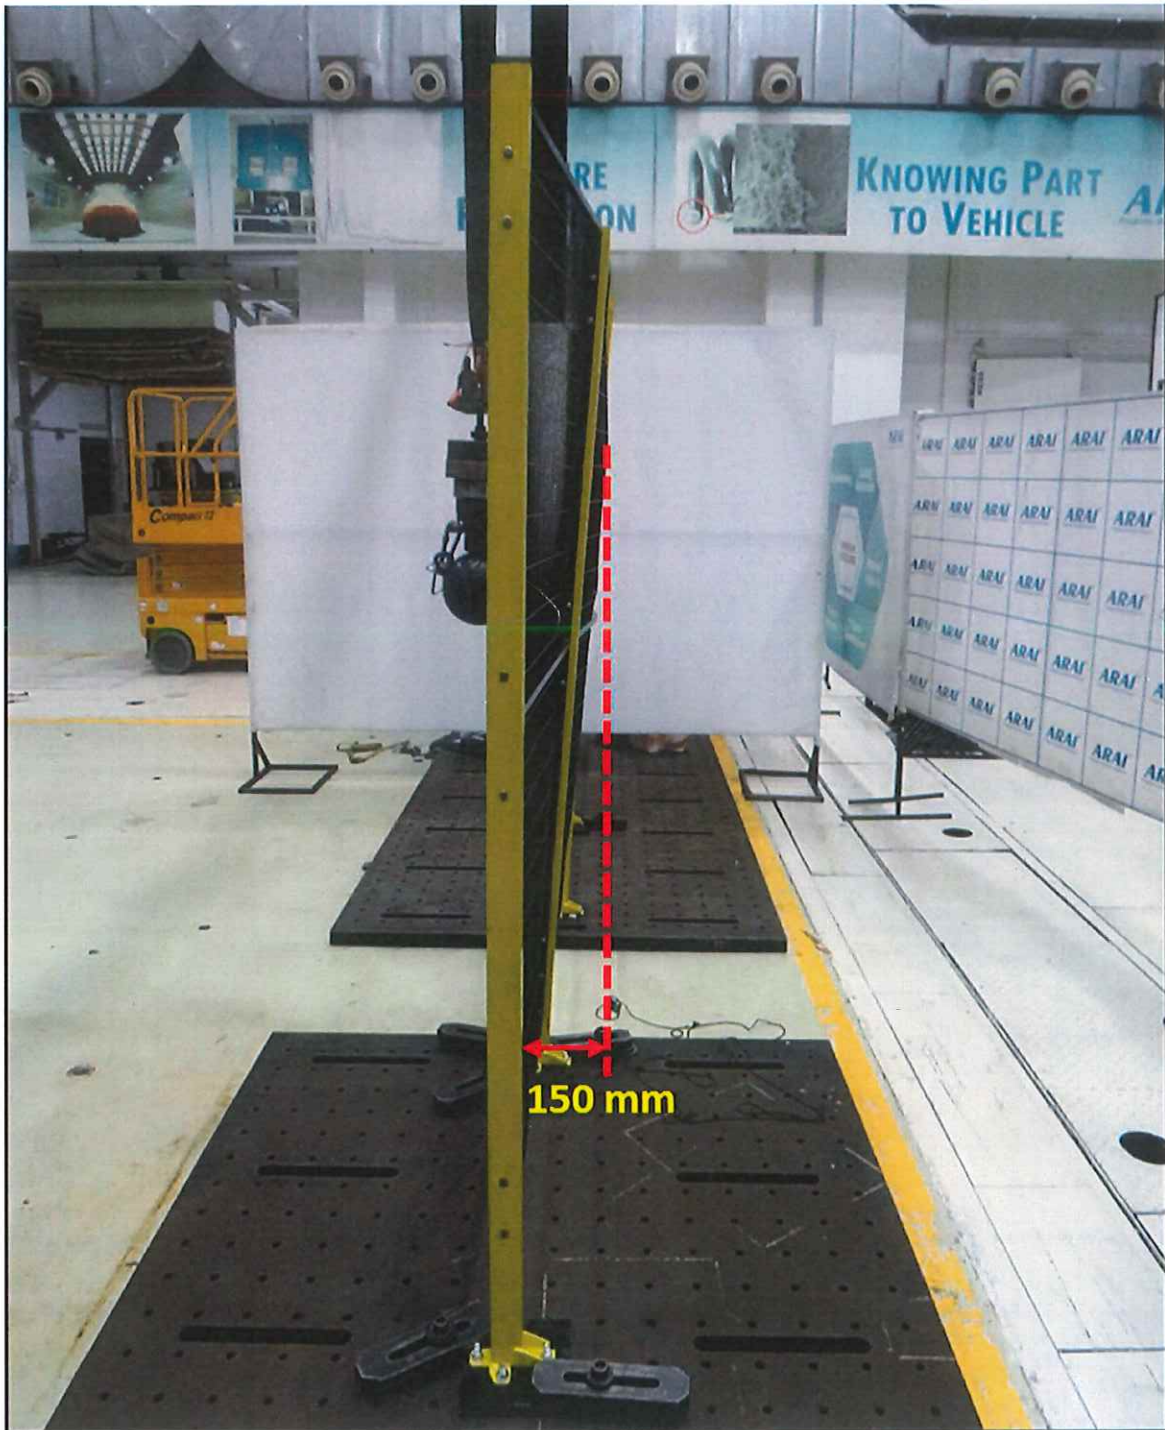
Figure 01 : Post Test Measurement

- 8.1 This test was conducted on 17th Feb 2023 in presence of representative from Swiza Safetech LLP.
- 8.2 Post-test, deflection recorded at centre panel was 150 mm. (refer figure 02 of Annexure - I)
- 8.3 With reference to standard IS 14120 following points were observed:
- 8.3.1 No any loosening of wire mesh was observed.
- 8.3.2 Machine guard support was intact with base plate and no any loosening observed for respective fasteners.
- 8.3.3 pendulum had not penetrated trough machine guard.
